# CLIMATE CHANGE AND CULTURAL HERITAGE

FINDINGS OF A RAPID VULNERABILITY ASSESSMENT  
AND RECOMMENDATIONS TOWARDS NATIONAL  
STRATEGIES FOR CULTURAL HERITAGE PROTECTION IN  
THE CONTEXT OF CLIMATE CHANGE

OCTOBER 2013

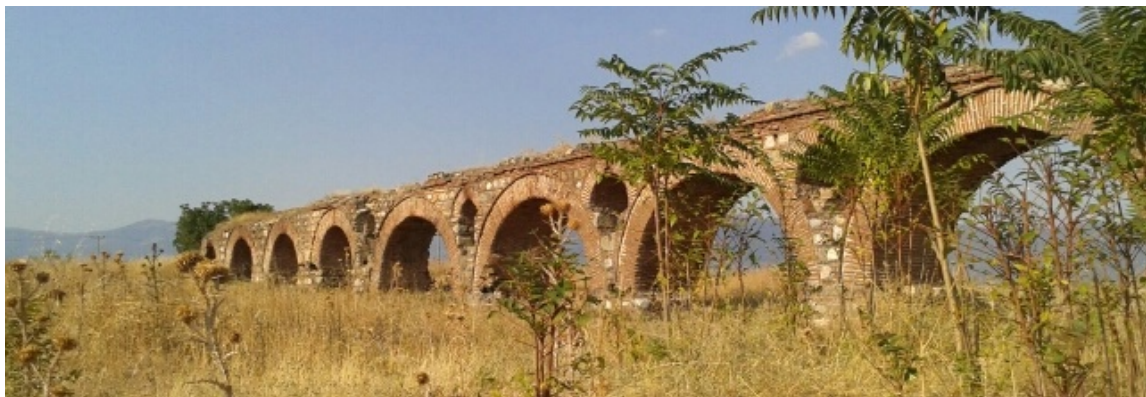
**PHOTO 1: NORTHERN SECTION OF AQUEDUCT**

The aqueduct visible today is a structure of 53 square and one rectangular piers, which resulted in 54 vaulted arch openings and two lateral ramps at both ends. It is preserved a length of 385.8 meters out of which some sections are only preserved in a fragmented state. The aqueduct is valued as a cultural heritage site and a historic water supply system likely dating back to the 6<sup>th</sup> century AD. However, with its elaborate masonry of alternating brick and stone components, it also has architectural and aesthetic qualities. With its linear structure changing at the one rectangular pier it provides a prominent feature and landmark in the wider landscape.

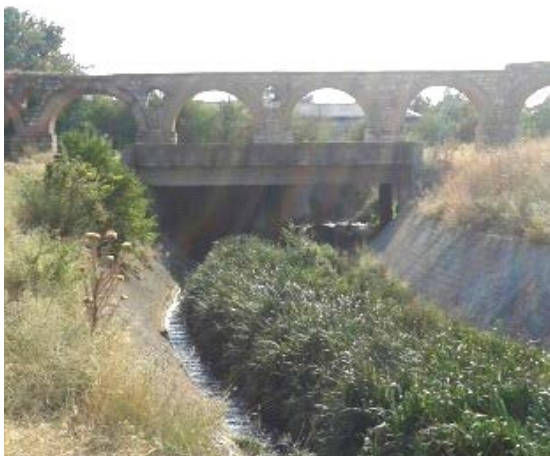
wider area of the Aqueduct and passed further south from its present location. Its canalization reduced it to a channel under the piers 31-33 and it may be likely that the destruction of these occurred in the context of the river canalization rather than a military exercise. The relocation of the river changed the ground water saturation of the soil in the southern part of the site. Previously highly water saturated soil is now no longer connected to the river, which streams at a faster speed through a concrete canal further to the north.

**PHOTO 2: CANALIZED RIVER BED OF SEREVA RIVER UNDERNEATH PIERS 31-33 OF THE AQUEDUCT**

In this context, the project idea to re-naturalize the river bed is highly welcomed; however, it also bears significant risks. The key risk is that through the reverted continuous water saturation in lower soils which have dried and settled over time, renewed larger soil settlements and shift may occur which the already destabilized arches of the aqueduct may no longer be able to compensate for. It is therefore essential, that the river denaturalization in undertaken hand in hand with a strengthening process of the southern aqueduct foundations which would preferably carefully move these back into vertical position.

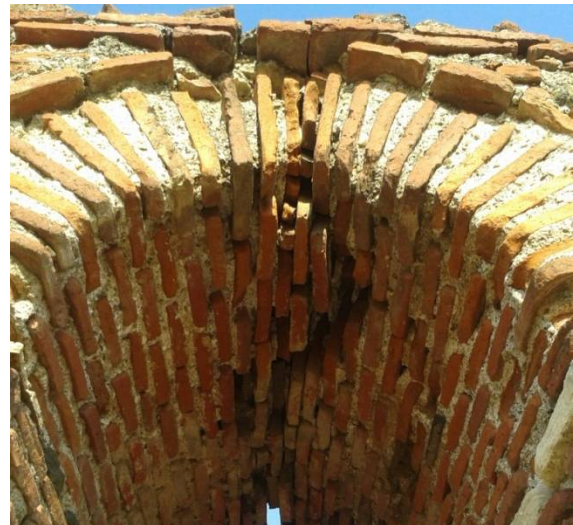
As a result the less saturated soil settled over the years leading to a soil compression under the aqueduct foundations, especially in the area of piers 19-27. The pier foundations moved with the settling and compressed soil and since the compression was not identical in all areas the foundations lowered into differing directions at different levels of the aqueduct, leading the architectural structure to significantly lean. Following these shifts out of the vertical angle on which the aqueduct was constructed, the transition of architectural pressures from the key stone of each arch towards the foundations has become disturbed. As a result upper parts of the arch structures and in particular the outer ornaments are no longer properly carried by the piers. The load bearing system of the construction directing pressure towards the piers has partially lost its proper function. As a result the upper aqueduct parts which are no longer carried are at risk of collapsing if further soil movements occur. Such movements can be accelerated by earthquakes – and likely the severe 1963 earthquake contributed its part to the current condition – but will likely be caused by further changes in ground water saturation.

**PHOTO 3: STRUCTURAL DAMAGES CAUSED BY SHIFTING FOUNDATIONS**

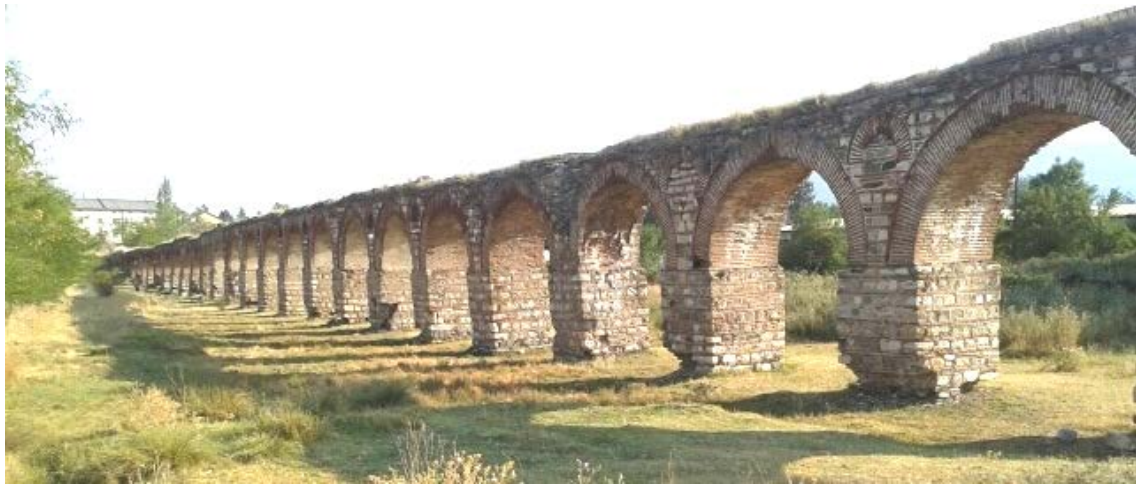
**PHOTO 4: LEANING PIERS (CA. 19-27) IN THE SOUTHERN PART OF THE AQUEDUCT AFFECTED BY SOIL SETTLEMENTS**

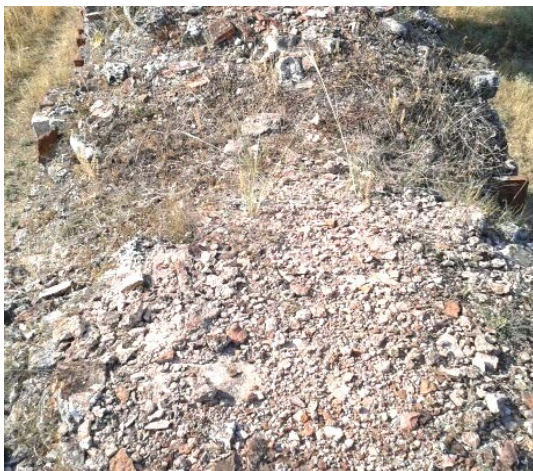
Rain water damages include those described above which cause the differences in ground water saturation and include surface water retentions, but also damages on the upper part of the architectural structures which shall be focused on in this section. Strong rain events have caused water erosion phenomena on the upper parts of the aqueduct affecting in particular the more recent piping elements of the early 20<sup>th</sup> century. Cracks and structural damages allow rain water to penetrate deep into the monument causing further damages, especially during frost periods. Damage phenomena which have occurred include signs of classic erosion along the edges of the upper levels but also further structural disintegration as shown on the image below.

**PHOTO 5: AQUEDUCT TOP SURFACE WITH DAMAGES CAUSED BY WIND AND WATER EROSION**

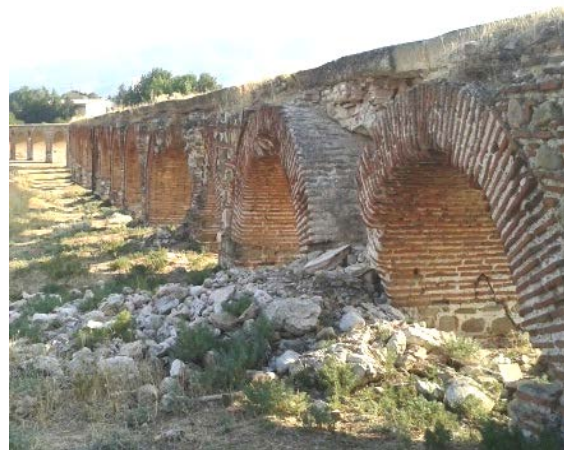
**PHOTO 6: DAMAGES CAUSED BY FROST EXPANSION FOLLOWING RAIN WATER PENETRATION**

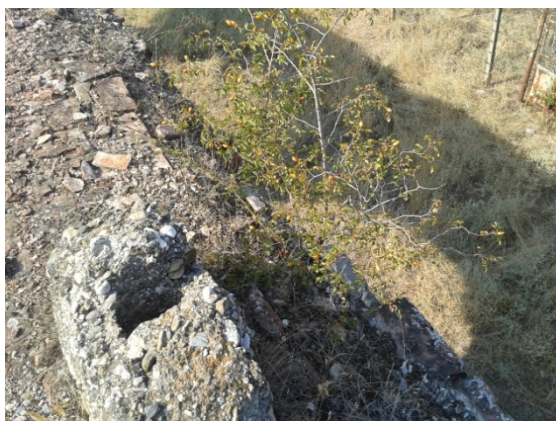
PHOTO 7: VEGETATION ON THE AQUEDUCT

Vegetation constitutes a third cause of decay and at times destruction, which has become quite massive after decades of no maintenance. In particular on the upper level on both sides of the pipe system vegetation is dense and roots of small trees inside crack and joints create internal forces pressing on the most exterior layer of brick stones. Regular maintenance could reduce this impact to negligible levels.

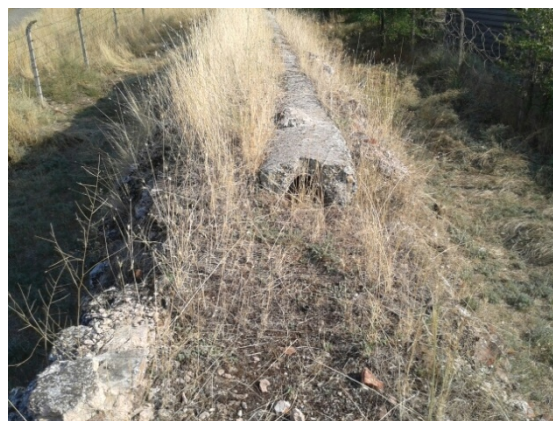
PHOTO 8: VEGETATION COVERAGE NEAR PIPE

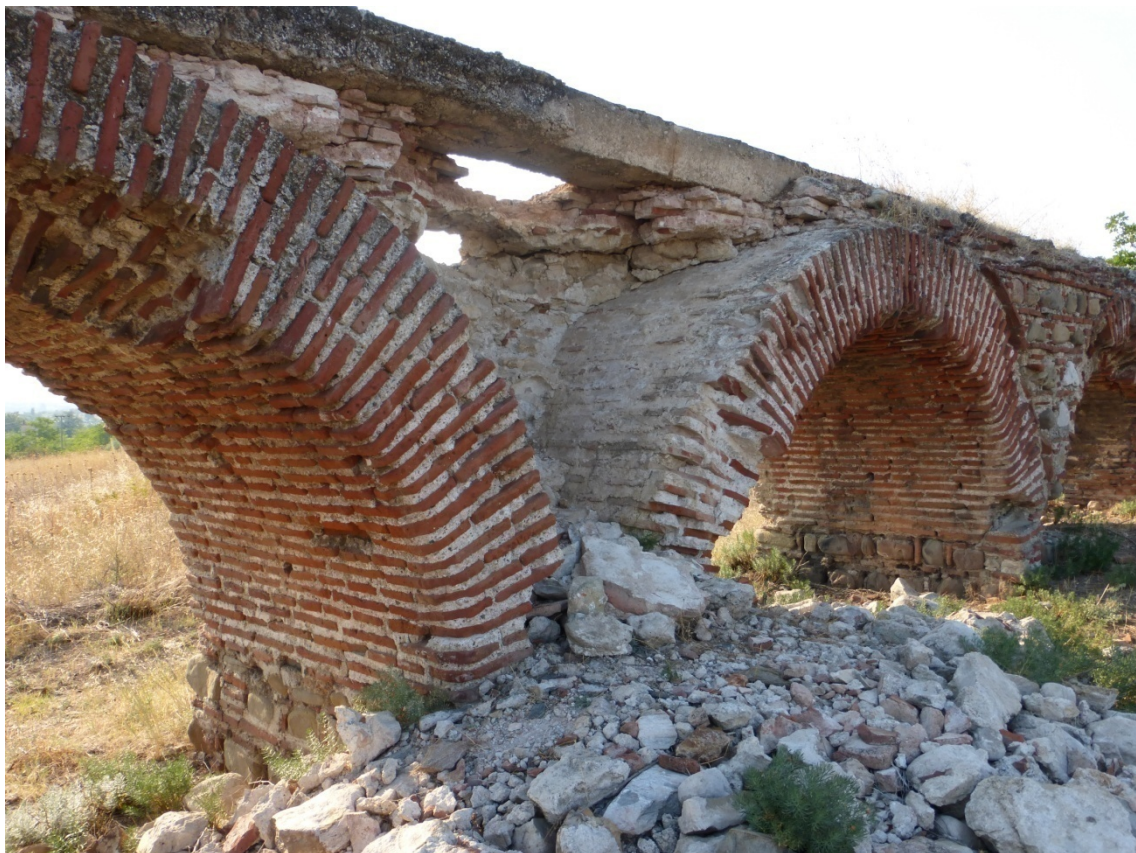
The damage to the bricks at the top of the aqueduct arches caused by frost shattering has currently reached a level where the sum total of the static structure is in acute danger. As a result of this damage, a brick arch loses its stability and collapses into itself. Built in the 19<sup>th</sup> century, the concrete channel on the apex of the aqueduct and the associated reconstruction project resetting the upper brick works in concrete mortar (photo 9) do not contribute to improved stability of the structure, but rather they will create a relic with no remaining structural integrity after the collapse of the arch.

**PHOTO9: DAMAGE TO THE BRICKS AT THE TOP OF THE AQUEDUCT AND BETWEEN ARCHES CAUSED BY FROST SHATTERING**

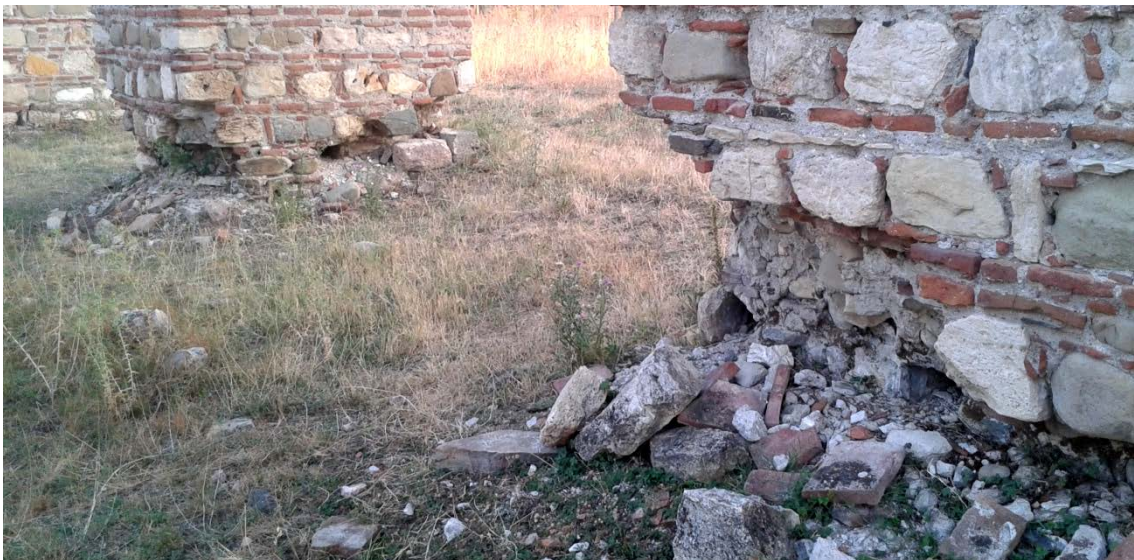
Increased incidences of heavy precipitation in the surrounding mountains will lead to temporary flooding. The concrete Serava canal near the aqueduct, as a result of its water flow design and margin, will ultimately lead to an increased rate of high velocity flow during floods. The enclosed channel shafts built in four sites in 1967 underneath the aqueduct also forms a barrier during heavy floods and subsequently floods the lower-lying areas containing the aqueduct arches. An increase in climate-related floods, therefore, will further degrade the already eroded aqueduct arch bases (photo 10) and flash flooding will continue to destabilize the overall statics of the structure.

**PHOTO 10: LOWE PIER AREAS WHICH ARE VULNERABLE TO FLASH FLOODS AND WATER EROSION**

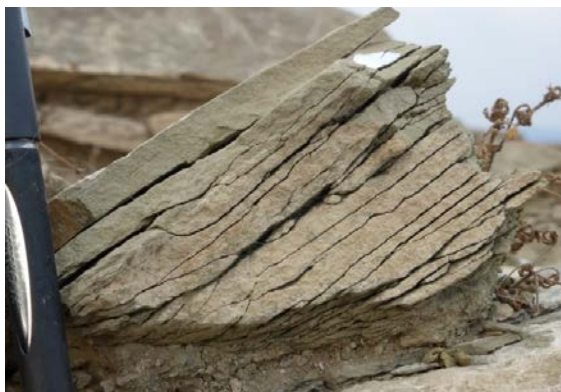
The current damage patterns are results of an evaluation during a two days field survey on the 24th and 25th August 2013 in the company of onsite archaeologists specialized in climate relevant aspects. Extensive examinations were not previewed with the framework of the evaluation, although they are necessary for the monitoring and success rating of possible adaptation measures. Conspicuous is the partially intense weathering of rocks and the ongoing washout of the bonding materials. Both sides of the wall exposed during the excavation of the middle and upper terrace are unstable in many parts and are characterized by progressive rock decay. The soft sandstone rock shows in a first macroscopic decay phase a plate-like cracking (see photo 11) probably the result of frost damage.

**PHOTO 11: SANDSTONE DECAY AS RESULT OF FROST DAMAGE**

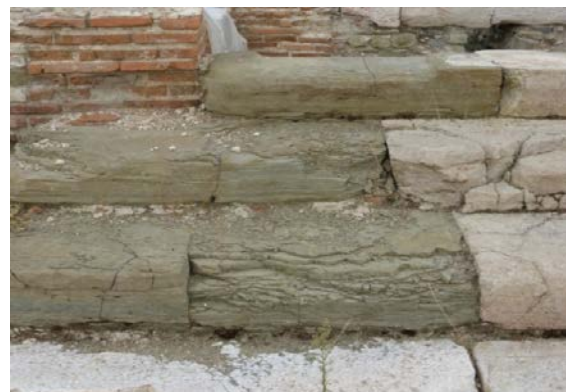
**PHOTO 12: DECAY PHENOMENA ON DIFFERENT STONE MATERIALS**

The particular sensitivity of gray sandstone against frost damage is shown by an ancient staircase in the middle terrace through the use of the different rock materials on photo 12. Here it is expected that the complete ancient appearance of the stairs will be lost in just a few decades.

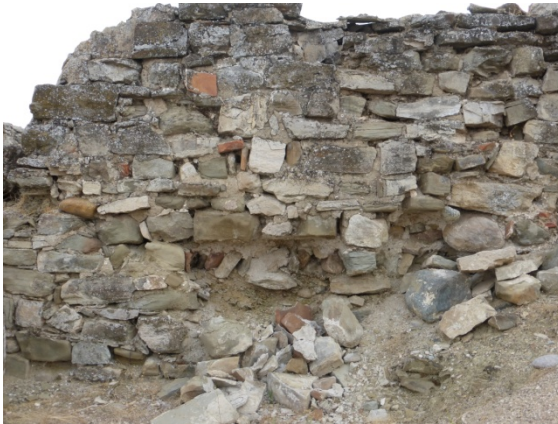
Further rock decay is characterized by the leaching of fine-grained particles whereby, the antique worked stone successively decays and loses its structural function in the rock mass. As a result, large areas of the rock mass will be removed (see photo 13) and/or both sides of the exposed walls will tip to the side (see photo 14).

**PHOTO 13: REMOVAL OF STONES AFTER BY THE LEACHING OF FINE-GRAINED PARTICLES**

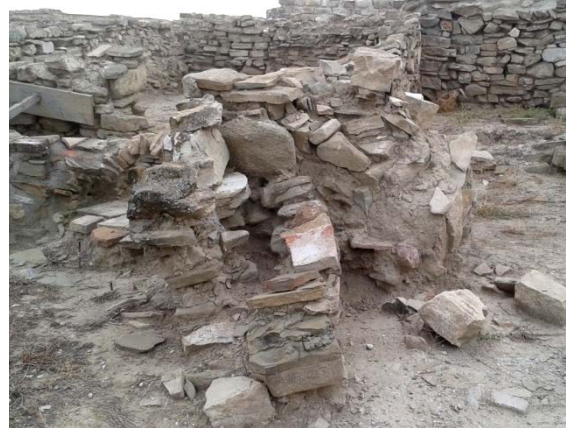
**PHOTO 14: TIPPING OVER AND COLLAPSE OF EXPOSED WALLS FOLLOWING MORTAR AND PARTICLE EROSION**

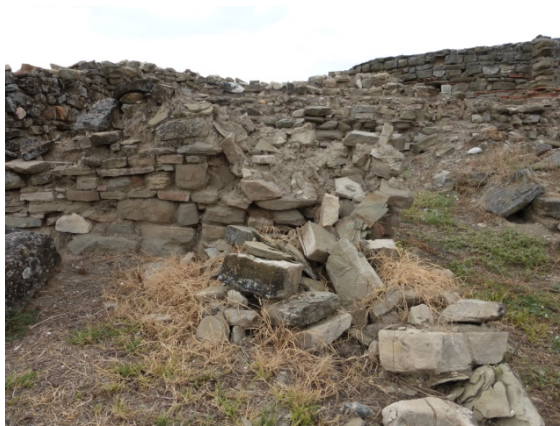
**PHOTO 15: COLLAPSED WALLS CHANGING THE CHARACTER OF THE ARCHAEOLOGICAL SITE**

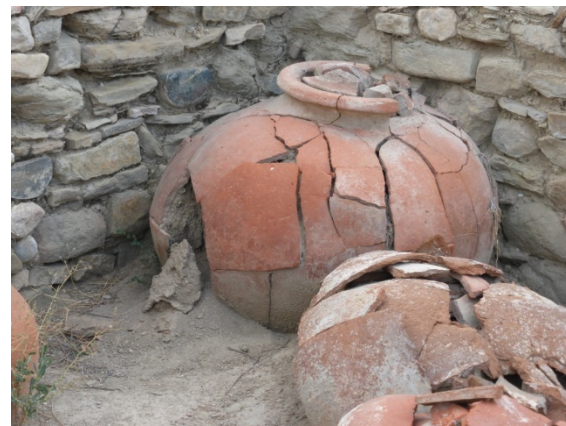
**PHOTO 16: CLAY VESSELS EXPOSED TO POTENTIAL FROST DAMAGE FOLLOWING THEIR EXCAVATION**

Progressive loss of the structure, especially both sides of the exposed wall, in addition to the decay of rocks represented above will be caused primarily by the washing-out of the bonding materials and mortars. This concerns both the unprotected walls and the lateral regions. As a result walls may break apart with loss of the original character of the antique site (see photo 15). Excavated and on-site remaining clay vessels are, despite their general strong resistance to external influences, equally exposed to potential damages by freeze/thaw events.

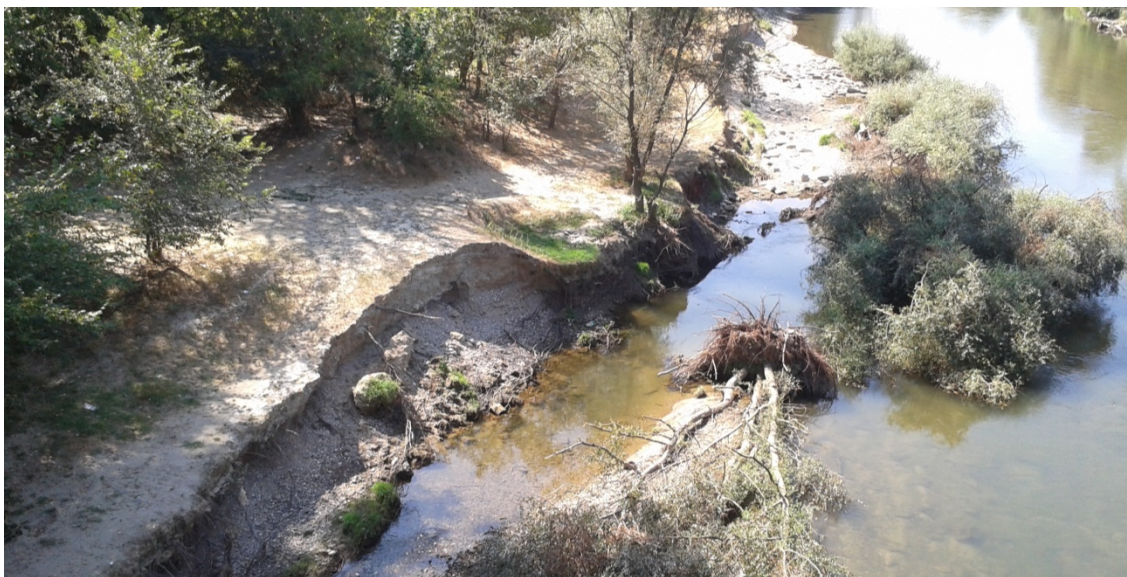
**PHOTO 17: TESTIMONY OF RECENT MAJOR FLOOD EVENTS AT CRNA RIVER**

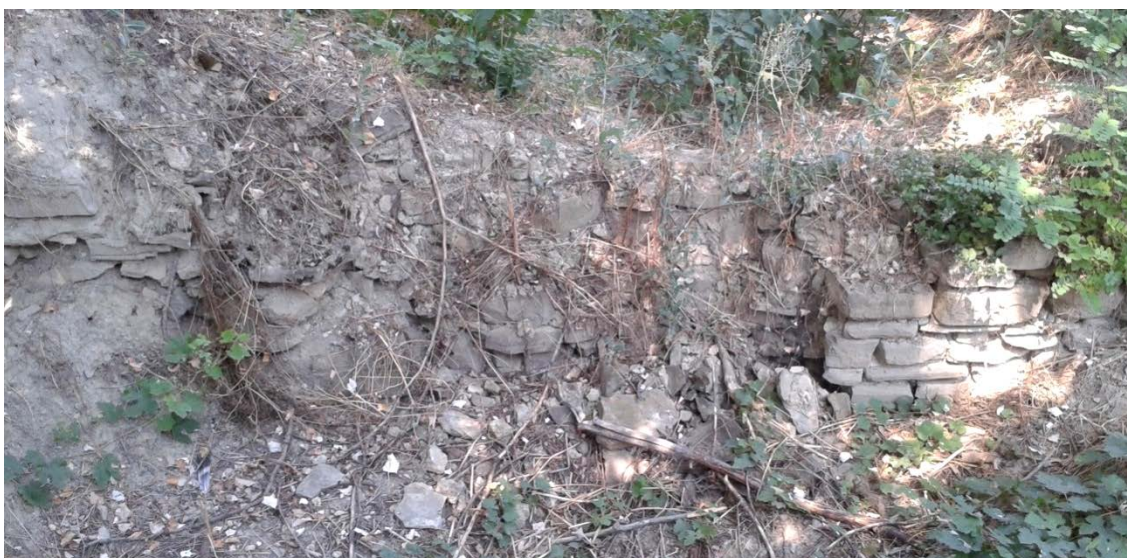
**PHOTO 18: FLOOD AND RAIN EROSION OF STEEP ARCHAEOLOGICAL STRUCTURES ON LOWER TERRACE**

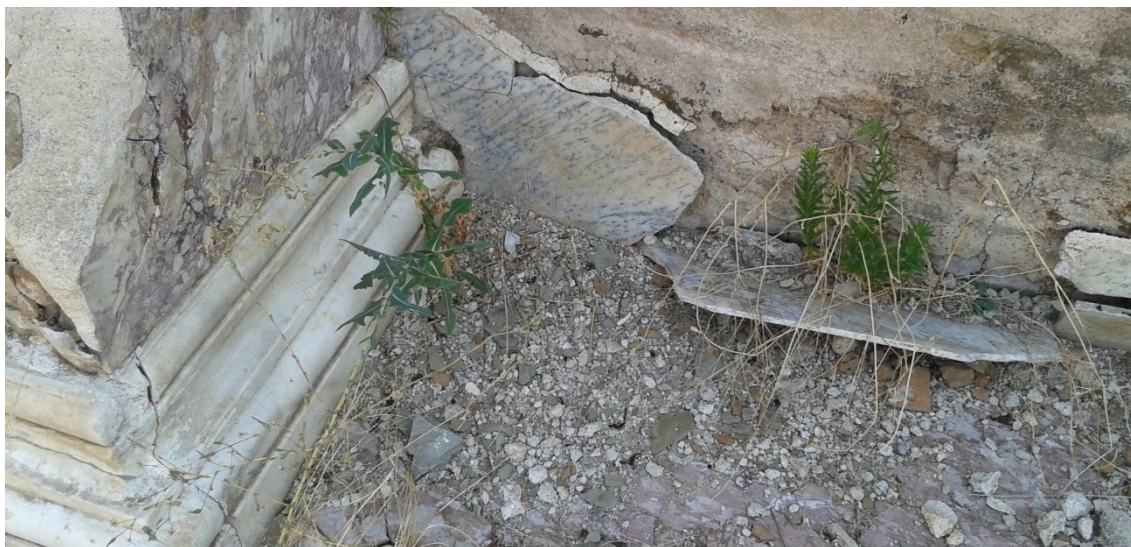
**PHOTO 19: SEPARATION OF SURFACE LAYERS AS RESULT OF FROST AND VEGETATION**

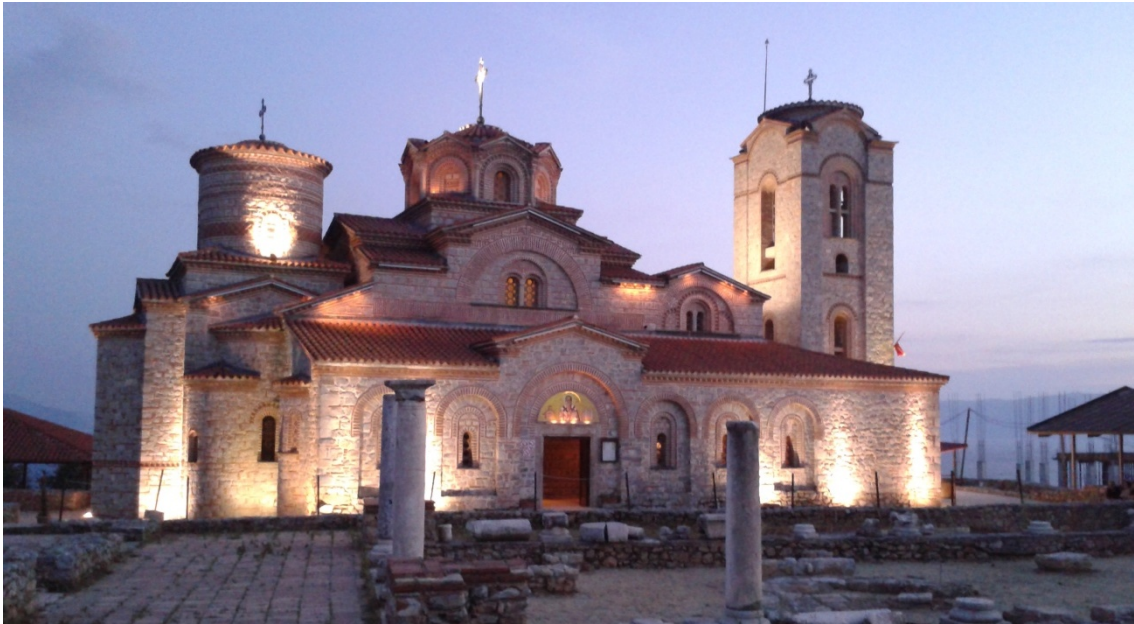
**PHOTO 20: ST. CLEMENT CHURCH AS RECONSTRUCTED IN 2002**

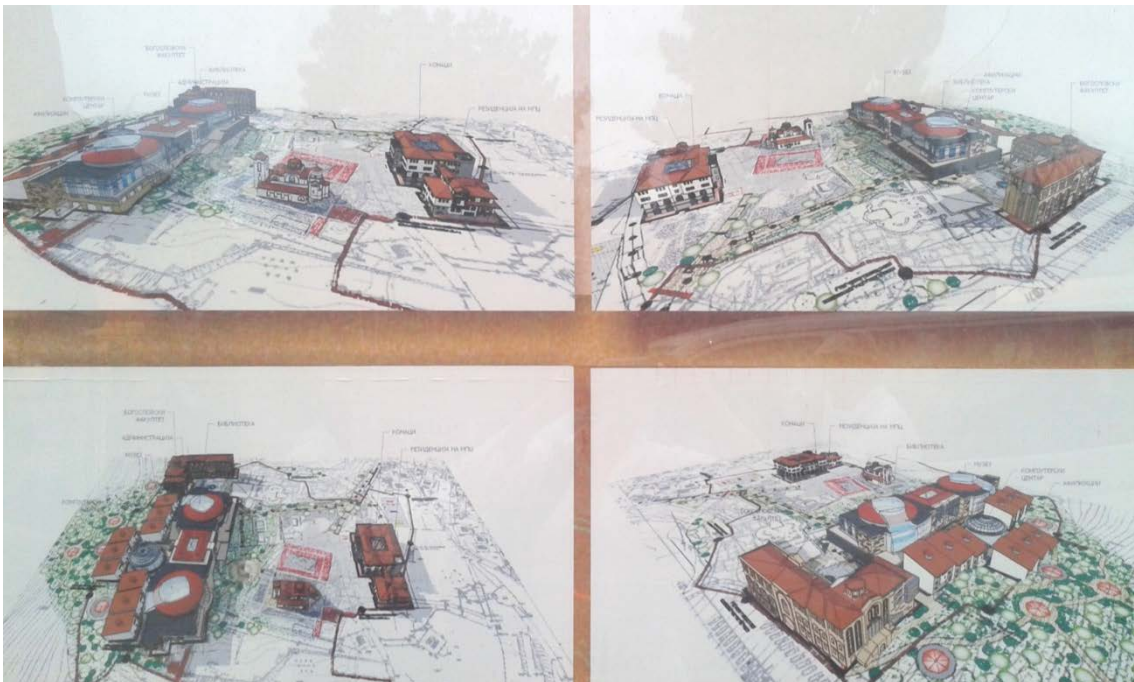
In the context of this report, the development project of St. Clement's university and monastery shall also be considered in terms of its evident and potential role in the acceleration of climate change phenomena, in particular rain water drainage mechanisms and soil water levels. Regardless of the climate change impact considered here, the project is likely to considerably change the physical and visual environment of the site. The study presented here can only roughly estimate the future impacts of constructions currently underway. The authors recommend undertaking further detailed studies and analyses once the constructions have progressed to a stage which would allow for judgment of the water flow off processes underneath and between the new concrete structures.

**PHOTO 21: ON SITE PANEL ILLUSTRATIONS OF THE ST. CLEMENT UNIVERSITY DEVELOPMENT IN RELATION TO THE EXISTING ST. CLEMENTS AND ST. PANTELEIMON CHURCH IN THE CENTRE**

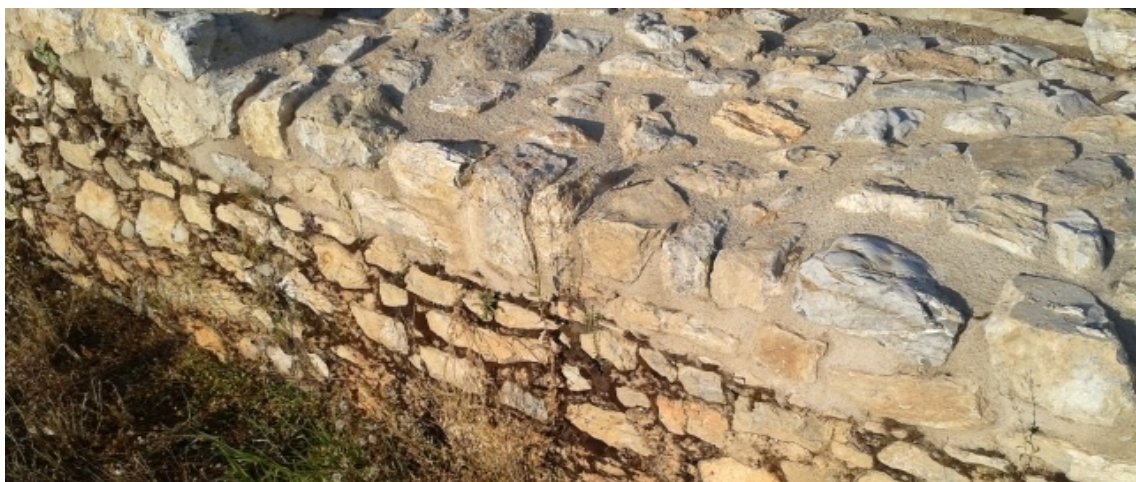
The site of Plaosnik is to the most extent well protected although several historic activities and conservation measures would likely be considered too extensive by international standards. It seems that after completion of archaeological excavations the archaeological remains are often consolidated by the addition of new top layers of stone which cover the historic ones and protect these from direct rain and wind erosion. In many places these additions are not only surface layers of a few centimeters but large wall sections built above the historic walls as reconstructions aimed at illustrating the former position and shape of the archaeological structures. More lately, mortar in slightly differing color has been applied to indicate the transition between historic and added substance.

**PHOTO 22: ADDITIONAL UPPER LAYERS INTRODUCED FOR THE PRESERVATION OF EXCAVATED HISTORIC WALLS**

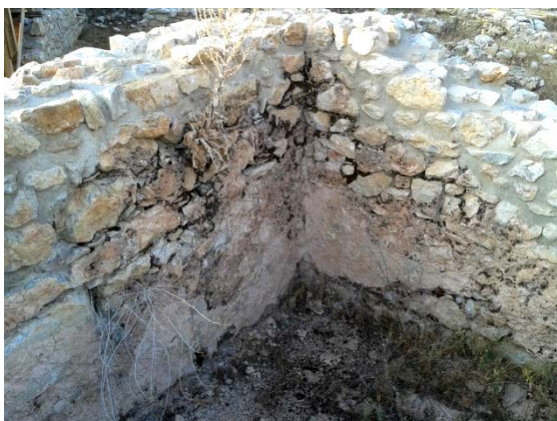
The key damage phenomenon on site – apart from the new construction – is uncontrolled vegetation growth. Harmful vegetation cover occurs in almost all sections of the archaeological property and affects not only the clay and stone floors, which have already been largely replaced to protect the original stones, but also the wall segments underneath the new additions. Merely below the shelters which were introduced for the protection of mosaics in the Roman basilica and a second liturgical structure further south, vegetation growth has been prevented by regular maintenance. In all other parts of the site maintenance routines for removal of destructive vegetation are urgently necessary to prevent further severe damages to the archaeological substance.

**PHOTO 22: VEGETATION GROWTH IN HISTORIC WALLS UNDERNEATH LATER ADDITIONS**

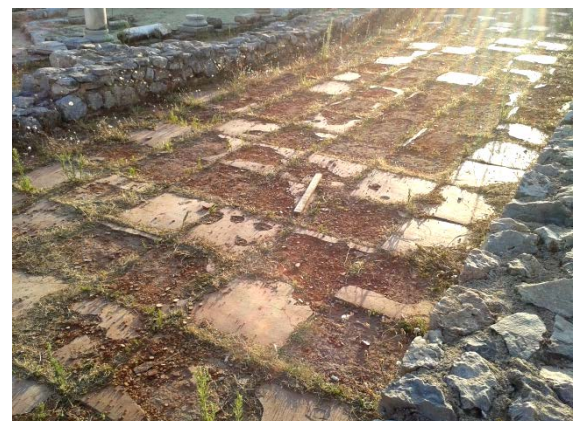
**PHOTO 23: RECONSTRUCTED BRICK FLOOR ILLUSTRATES DAMAGE BY FROST AND VEGETATION**

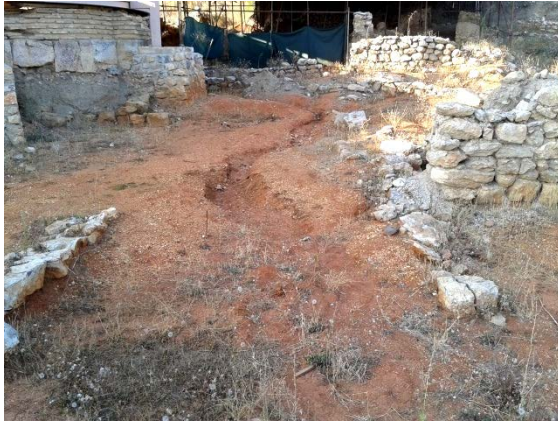
**PHOTO 24: WATER RUNOFF STREAMS IN ARCHAEOLOGICAL EXCAVATIONS**

Additional damage phenomena occur as a result of thaw transition and frost as well as rain water runoff and wind erosion. Although these phenomena are widely controlled, partly by shelter structures, partly by temporary drainage systems installed on site, yet, their occurrence cannot be fully prevented. Especially the rain water runoff is of concern for the anticipation of future climate change phenomena, as the newly developed structures on site seem to block previous drainage directions and run off patterns.

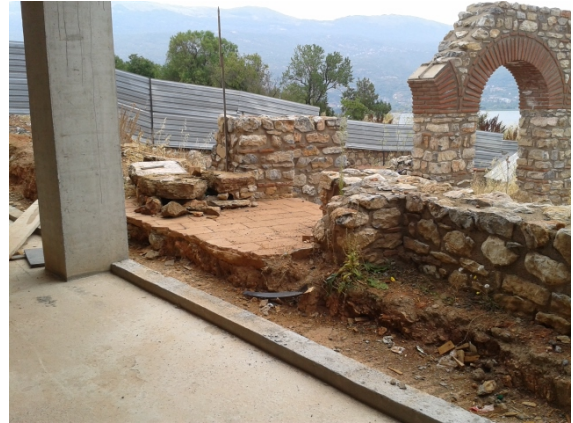
**PHOTO 25: IMPACT OF NEW CONSTRUCTION ON ARCHAEOLOGICAL STRUCTURES**

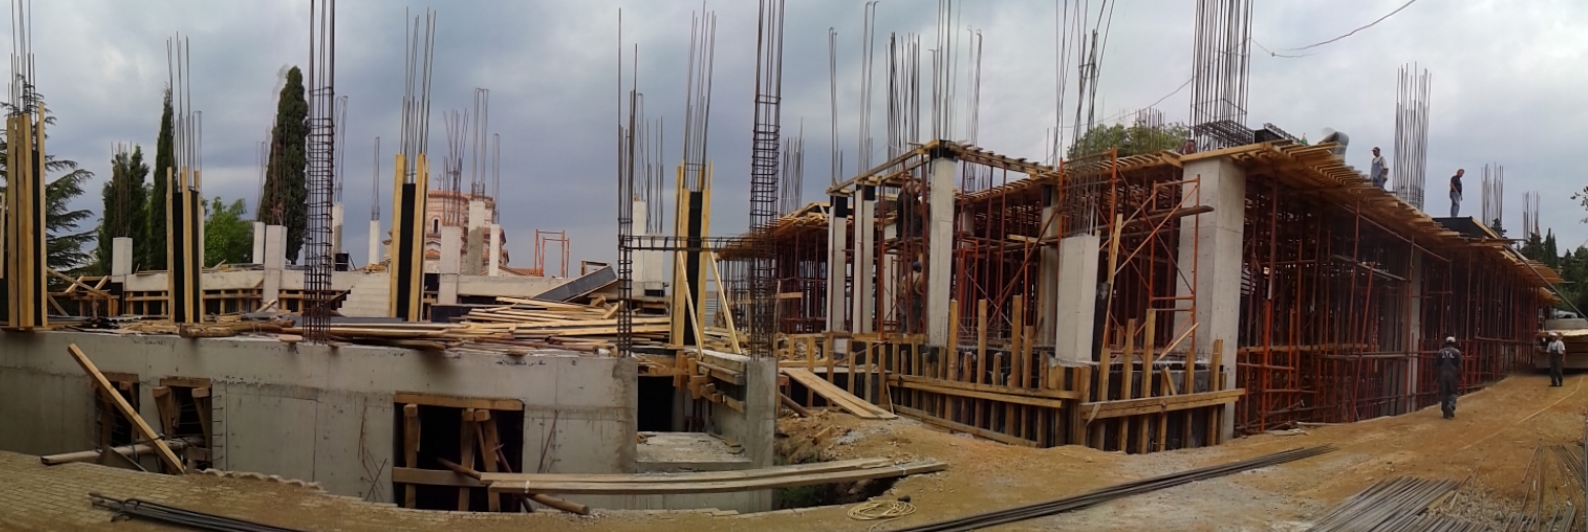
PHOTO 26: CONSTRUCTION OF THE MONASTIC COMPLEX OF ST. CLEMENTS ON THE EASTERN PART OF PLAOSNIK

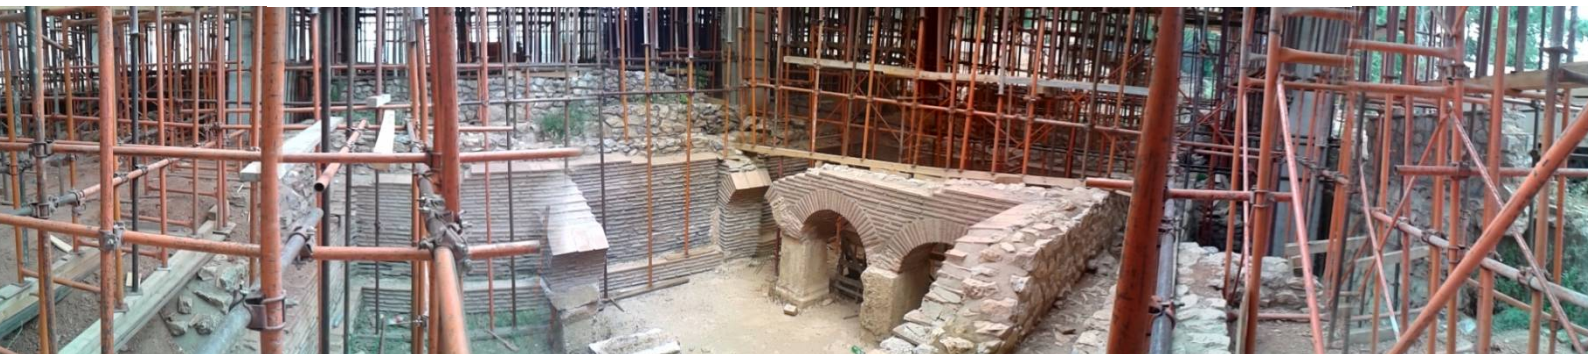
PHOTO 27: INTEGRATION OF ARCHAEOLOGICAL STRUCTURES IN THE NEW MONASTIC COMPLEX OF ST. CLEMENTS ON THE EASTERN PART OF PLAOSNIK

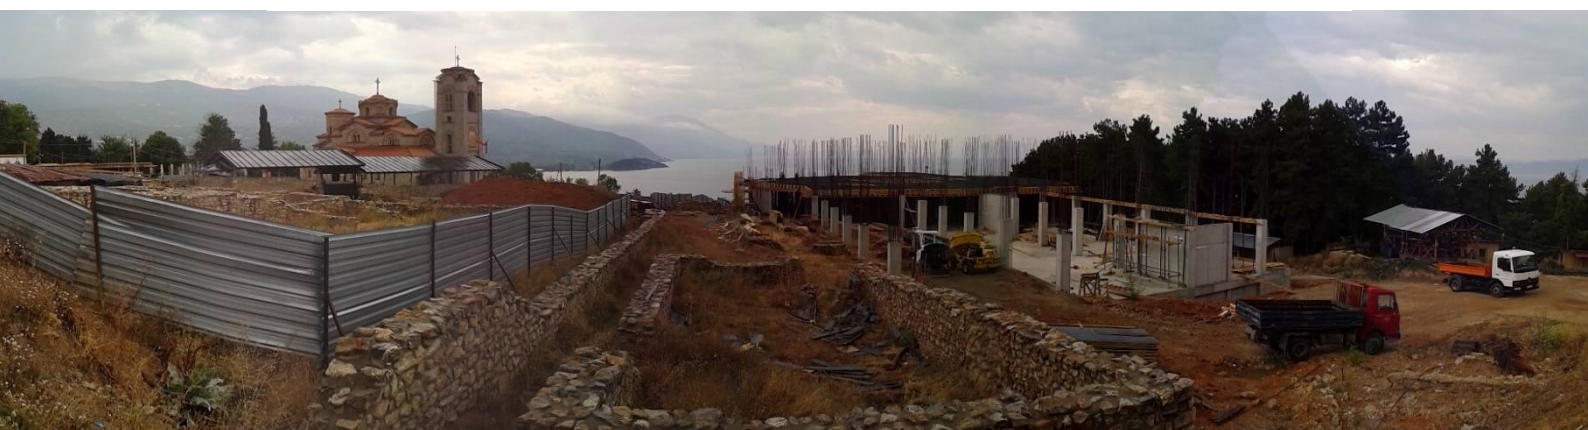
PHOTO 28: CONSTRUCTION OF THE ST. CLEMENTS UNIVERSITY COMPLEX WITH INTEGRATED MUSEUM ON THE WESTERN PART OF PLAOSNIK

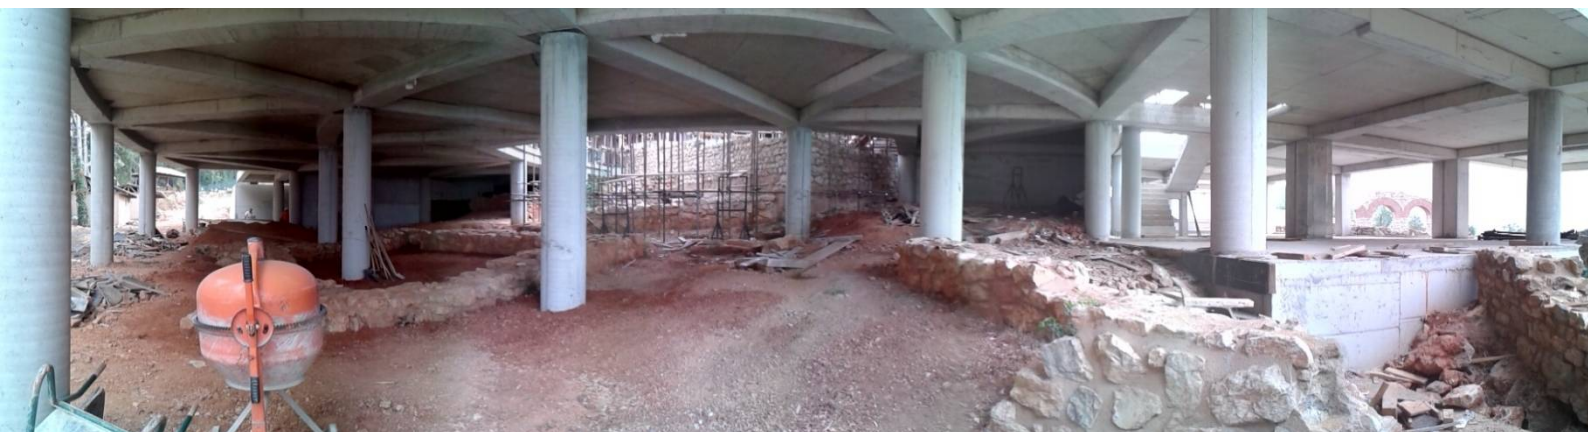
PHOTO 29: INTEGRATION OF ARCHAEOLOGICAL REMAINS IN ST. CLEMENTS UNIVERSITY COMPLEX

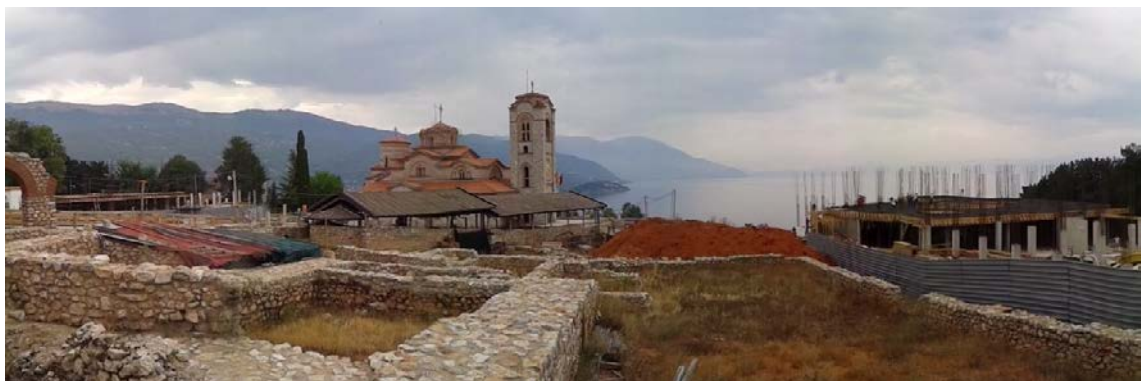
**PHOTO 31: ARCHAEOLOGICAL STRUCTURES BETWEEN THE TWO DEVELOPMENTS WITH POTENTIAL TO BE AFFECTED BY WIND AND WATER EROSION**

The authors further recommend investigating whether the north-south channel created between the two new high building complexes on the top of the Plaosnik plateau with full exposure to Ohrid lake, will create particularly strong wind currents and drifts and may be expected in such artificial channels. If wind speed and strength increase disproportionally in comparison to other locations in and around the archaeological site, further protective measures against wind erosion would need to be taken. Such measures can either be the regular maintenance of added top layers which act as sacrificial layers for wind erosion to preserve the historic substance, the backfilling of parts of the previous excavations or the deliberate creation of wind breakers in form of glass walls or other features to protect particularly valuable sections of the archaeological site.
